Case Study

Service: Magnetic Particle Inspection

Location: Rathbone Place, London

Client: Careys

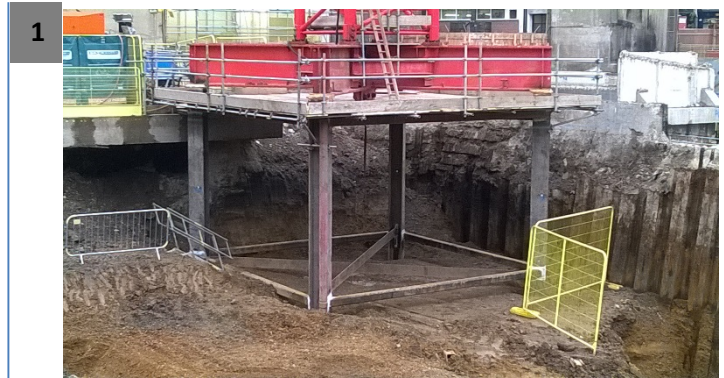
Swantest were employed by Careys to carry out Magnetic Particle Inspection on the newly designed and fabricated Tower Crane base at their site at Rathbone Place, London.

1. TC3 Crane Base
2. TC3 Crane base areas of Inspection
3. MPI of Structural welds
4. MPI Burmah Castrol Strip (Flux Indicator)

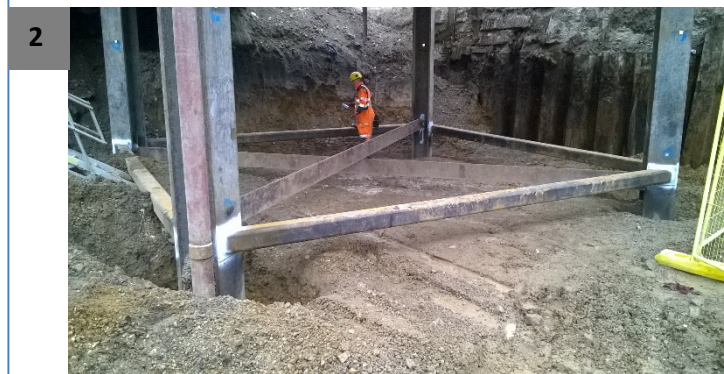
After a Visual Inspection, looking for any obvious weld defects or imperfections present, the Magnetic particle inspection was carried out on all of the specified weld areas.

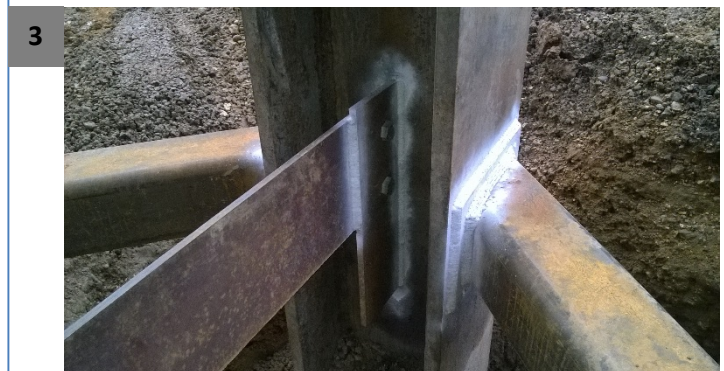
No Surface breaking indications were found therefore the welds were found to be acceptable to the Specification: National Structural Steelwork Specification for building Construction – NSSS Version 5
