Case Study

Service: Concrete Scanning

Location: Maran Way, Thamesmead

Client: Gump & Maier GmbH

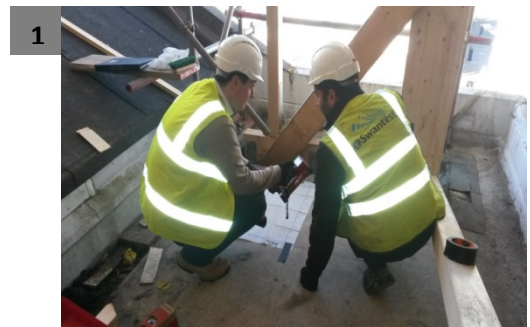
1. Concrete roof slab scan at Gump & Maier site.
2. Preparing an image scan using Hilti PS 200 Ferroscan
3. Results from scan using Hilti PS 1000 X Scan Radar Detection System
4. Sample of digital imagery provided supporting our reports and giving realistic representations of findings on site
