Case Study

Service: Floor Load Capacity Test

Location: Civic Center, Reading

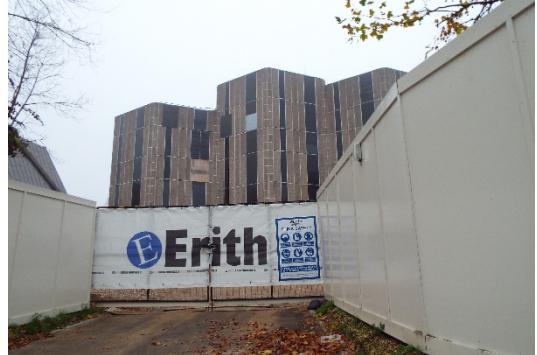
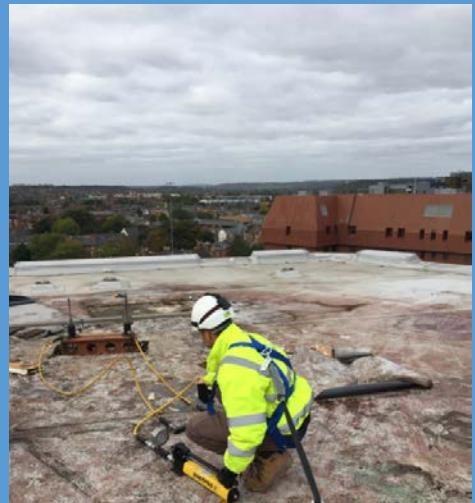
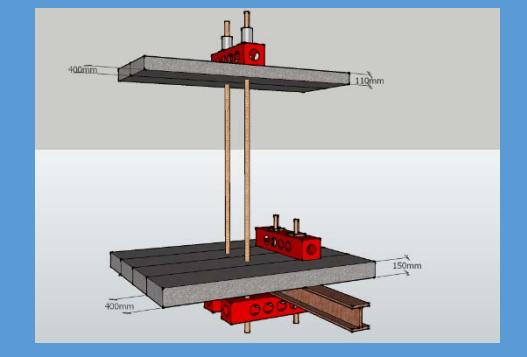
Swantest implemented one floor load test on the roof floor slab. The 15th floor slab was used as a restrain slab for this test (see test setup), clamping the steel beam with two RMD's.

Prior to testing, the floor slabs and soffits at each level were checked for any signs of existing cracking or distress. The heights from floor to ceiling at each level was also noted. At each increment of loading the heights from floor to ceiling were recorded again to note any deflection in the slabs. A visual inspection of each level was also carried out.

Due to site constrains we were only able to test in one location. There are asbestos removal works on numerous sections of the building preventing access. The best means of providing restraint is using the existing steel beam framework. There was really only one area we successfully utilize the steel frame to carry out a test.
