Case Study

Service: Non Destructive Integrity Test of Architectural Fin

Location: Premier Inn Hotel, Corsham Street, London

Client: Ardmore Group

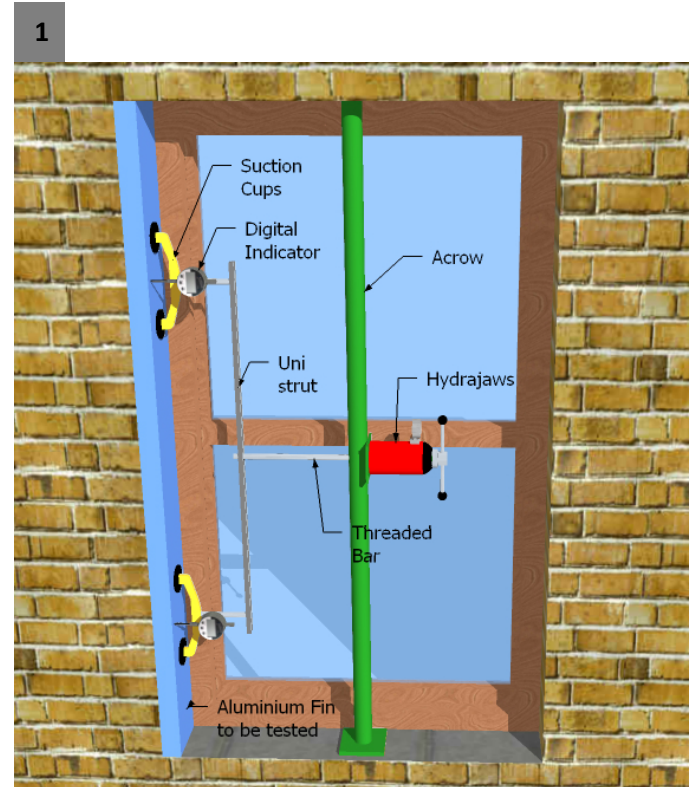
1. 3D sketch of the architectural fin
2. Testing rig clamped in position
3. Test in progress with dial gauges to record deflections

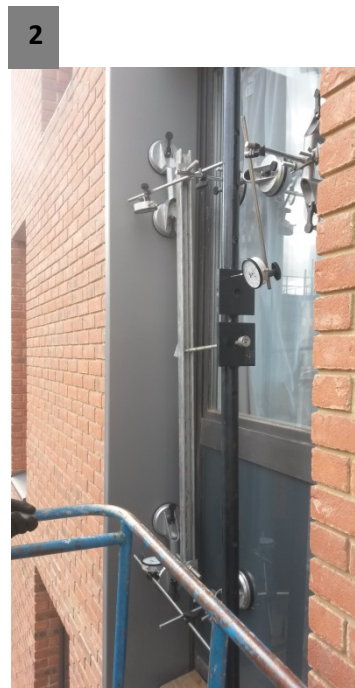
Knowing the surface area of each fin, and using a specifically calculated safety factored wind load for this area, we conducted the tests using our bespoke testing rig.

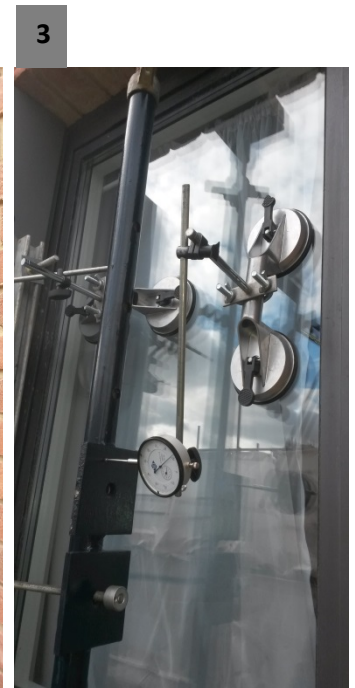
Any distress or deflection of the fin, visible fixings or surrounding area was to be recorded and investigated.
