## Case Study

**Service:** Shear Testing Anchors

**Location:** Belsize Park, London

**Client:** CJ O'Shea & Co Ltd.

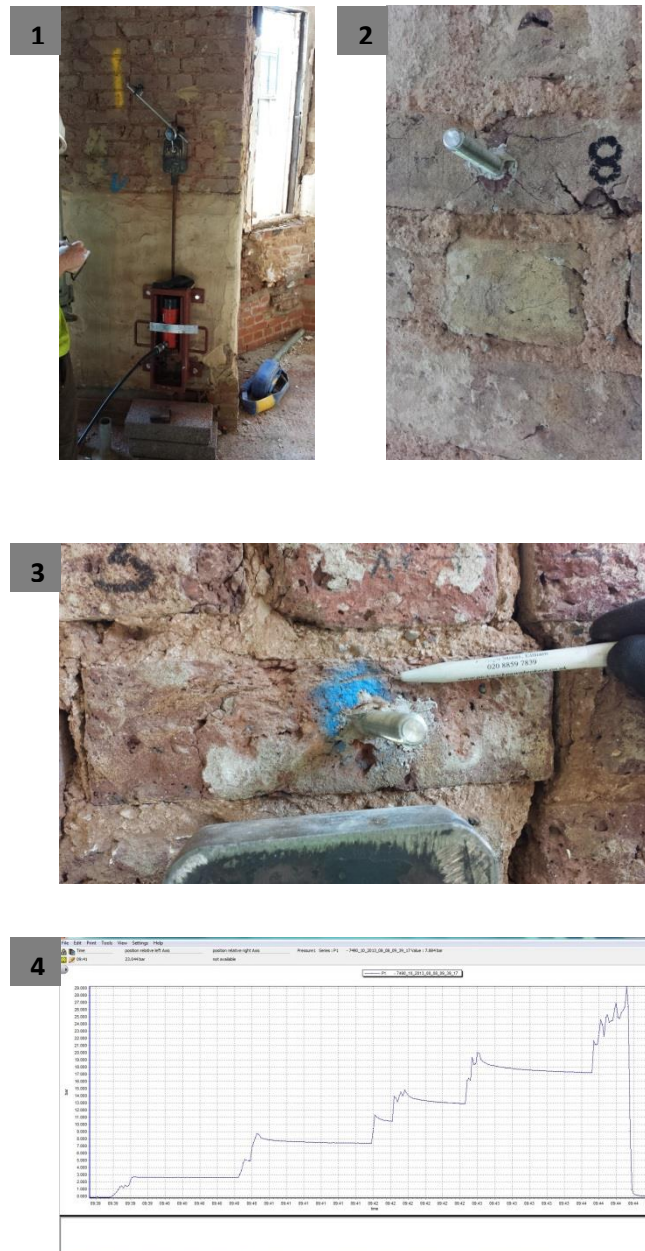
1. Test apparatus for Shear Test
2. Failed anchor under shear. The base material failed
3. Failed anchor under shear. Showing one of the three cracks developed on the base material.
4. Graph produced using a digital gauge showing the applied pressure to the anchor over time.

A custom made shear rig was used for the test combined with a digital pressure recorder to accurately apply and record loading.
