Case Study

Service: Plate Bearing Test (CBR)

Location: Beckton Sewage Treatment Works

Client: Erith Contractors

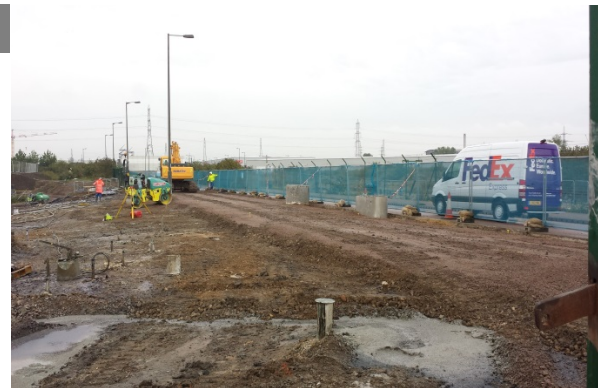
1

1. Beckton Sewage Works – Realignment of temporary road
2. Plate Bearing Test in progress using 20t excavator
3. Typical Set-Up – Steel plate being loaded against undercarriage of excavator & dial gauges measuring the deflections in the plate
