Case Study

Service: Shear Vane Testing

Location: Earlswood Junior School,
Redhill, Surrey RH16JX

Client: Miller Construction

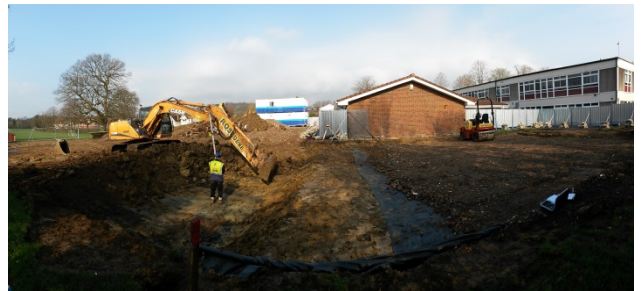
1

1. Miller site being reduced to formation level.
2. Profile of excavation showing varying soil/clay layers
3. Trial pits dug for quick assessment of natural ground
4. Hand Shear Vane utilises 19mm or 33mm vanes
